Risk – Wheel Stops

Existing conditions - 107 Muriel Avenue, Moorooka

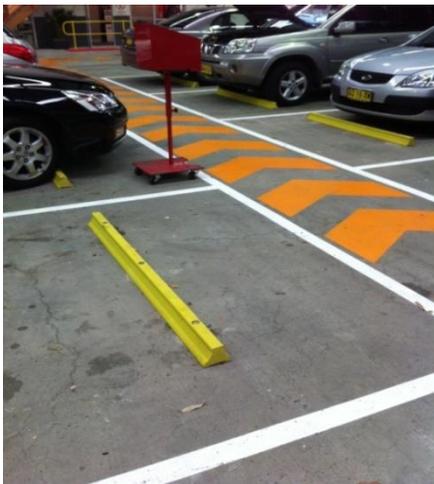
Wheel stops designed as per AS 2890.1:2004 Parking Facilities off Street Car Parking, refer to long concrete, rubber or other fixed material blocks that are used to impede the movement of vehicles. They are advised only for use in the protection of a fixed asset and their use in pedestrian areas should be avoided due to the trip hazard they pose. Wheel stops are not recommended for use adjacent to a marked pedestrian walkway. A pedestrian straying over a pedestrian walkway line would then be exposed to the trip and fall hazard. This is particularly true in the event that the marked pedestrian walkway is used by persons with a disability.

Recommendation - Removal of wheel stops and the addition of barrier post and rails or double U Bar type installations are a more desirable option, refer to pictures on page 3. Barriers such as post and rail designs should be installed in such a manner as to prevent parked cars encroaching on the pedestrian walkway whilst providing a far more visible option than wheel stops when no cars are parked in the bays.

Ensure barrier gaps are present at each parking bay to allow pedestrian and wheel chair access to the centre pedestrian footpath as per Diagram 1 refer to AS2890 for dimensions and specifications.

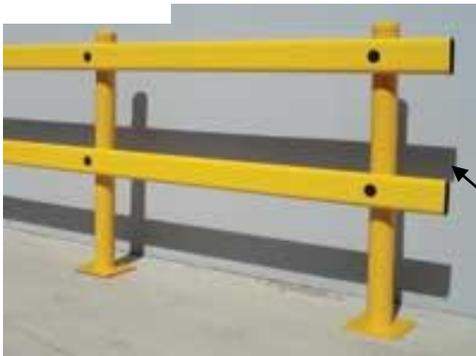
Diagram 2

Examples of alternative barriers to control vehicle and pedestrian access

The barrier installations should be hard fixed and reflective and at a suitable height and suitably spaced to ensure adequate access to and from vehicles for pedestrians (also considering disabled access requirements) for all such installation specifications refer to AS/NZS 2890.1:2004 Parking Facilities Off Street Car Parking and AS/NZS 2890.6:2004 Off Street Parking for persons with a Disability.
